# Richmond Refinery LPS Alert – Safety Driving on Refinery Roads

Impact ERM: 39919,  
39948, 39945

**Location:**  
Blending & Shipping

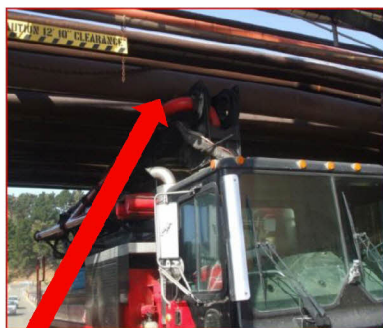
Concrete pump truck under the  
pipe way at Ethyl Road

The 1<sup>st</sup> incident occurred on Ethyl Road when a concrete pump truck hit an overhead pipe way with a vertical clearance of 12'8". There was an apparent lack of recognition on the risk associated with the overhead clearance on Ethyl Road.

1. Both product lines involved were immediately inspected and results showed no damage so no repair activity was necessary.
2. The overhead chains on Ethyl Road were restored and a more visible caution sign was installed to provide the low clearance warning.
3. The grating was properly fastened using designed hardware.
4. A safety stand-down meeting was conducted in Blending & Shipping to share the 3-MVCs.

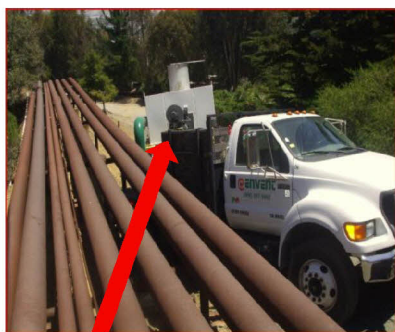
Truck towing a 12-ton  
degassing equipment trailer  
leaning on #12 Mogas line

The 2<sup>nd</sup> MVC occurred when a truck was towing a 12-ton thermal oxidizer near T1686. The truck lost traction, skidded back 15 ft, causing the truck and the trailer to jackknife and the wooden section of the truck bed to land on the #12 Mogas line, which caused the pipe to move by about 5". The Refinery Transport Department (RTD) and Plant Protection immediately responded. JJSV was conducted and mitigations were put in place to safely remove the truck and trailer.
